FOSTERING DISASTER RISK REDUCTION FOLLOWING DISASTER: AN EXAMPLE FROM NEW ZEALAND

Rebuilding Napier following the 1931 earthquake

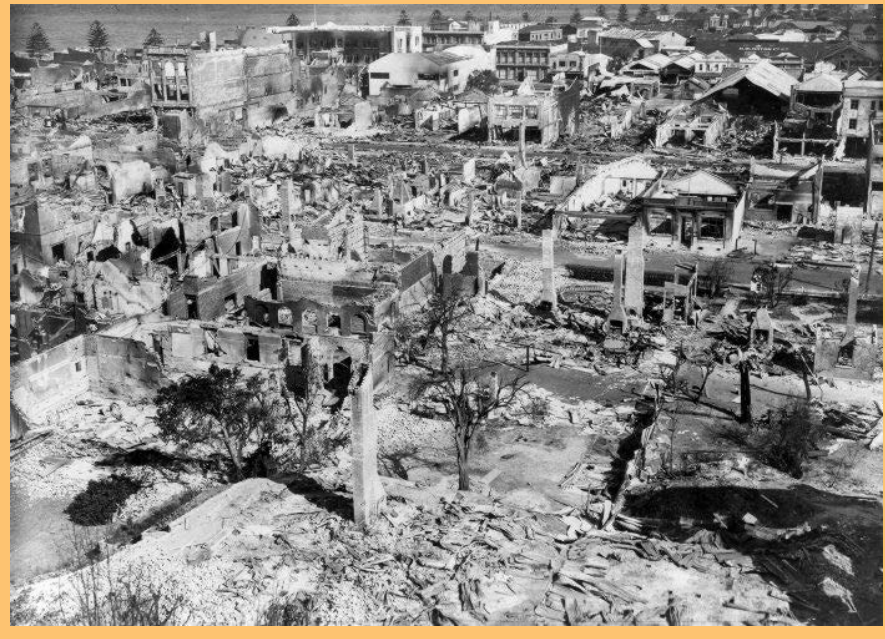
Napier Central Business District damaged by the 1931 earthquake (S.C. Smith / A. Turnbull Library)

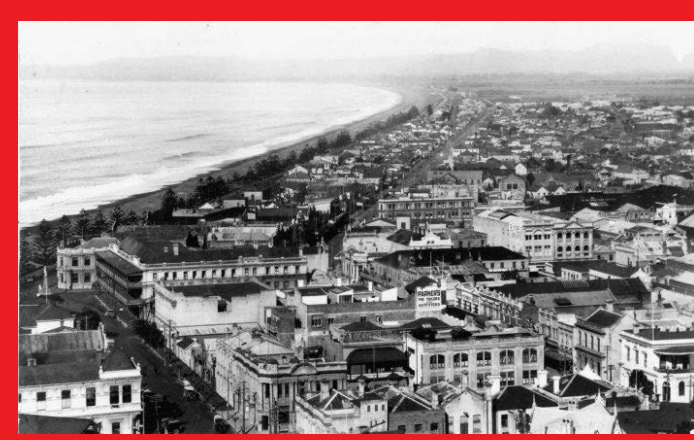
Napier Central Business District in 1929 (P.C. Sorrell / A. Turnbull Library)

The layout of the city reaped consequences during the earthquake. The high concentration of buildings in the CBD with relatively narrow streets exacerbated the damage and danger caused by falling infrastructure and

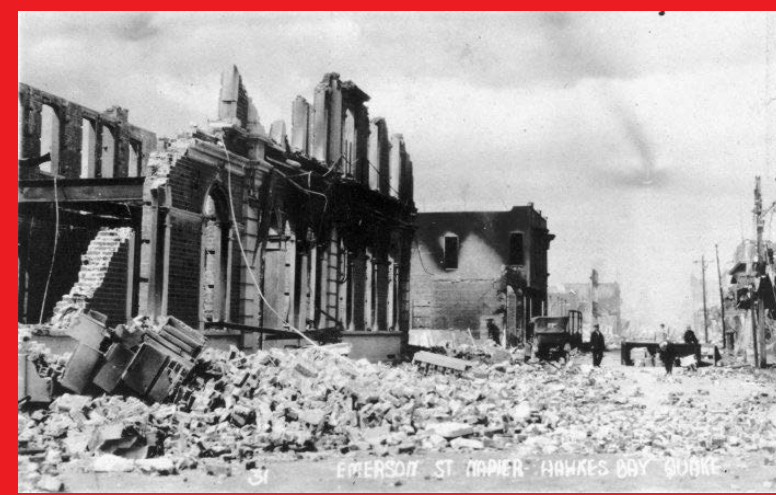
Buildings damaged by the 1931 earthquake in central Napier (Anonymous / A. Turnbull Library)

Buildings varied in height, mostly above two storeys high. Many had facades that proved very dangerous during the earthquake. Numerous were made of unreinforced masonry.

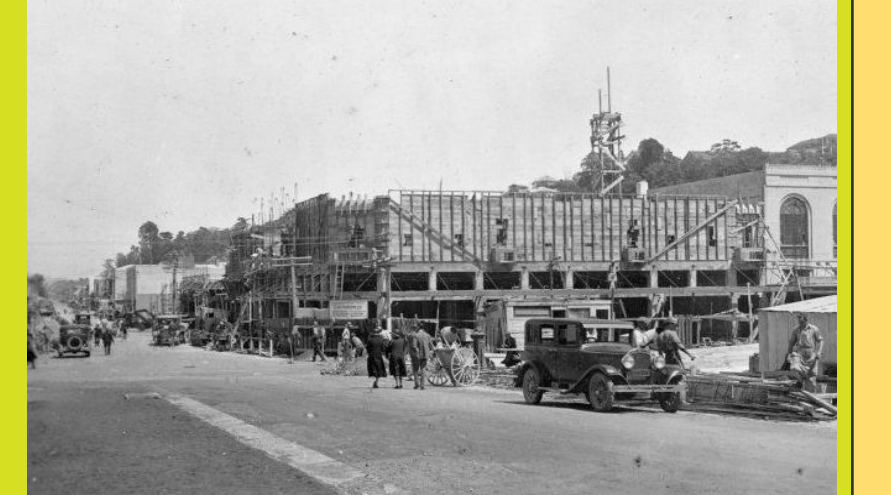
Rebuilding in central Napier including resistant framing and splaying of the corner (Anonymous / A. Turnbull Library)

New buildings erected in the aftermath of the 1931 disaster do not exceed two storeys. They also included the use of reinforced concrete boxes and the splaying of corners. The construction of veranda was strictly regulated.
